Pico Technology Case Study

Jaguar E-type
3.8 Series 1
two-seater

Unstable idle speed, reluctance to rev, backfiring and wide open throttle (WOT) hesitation.

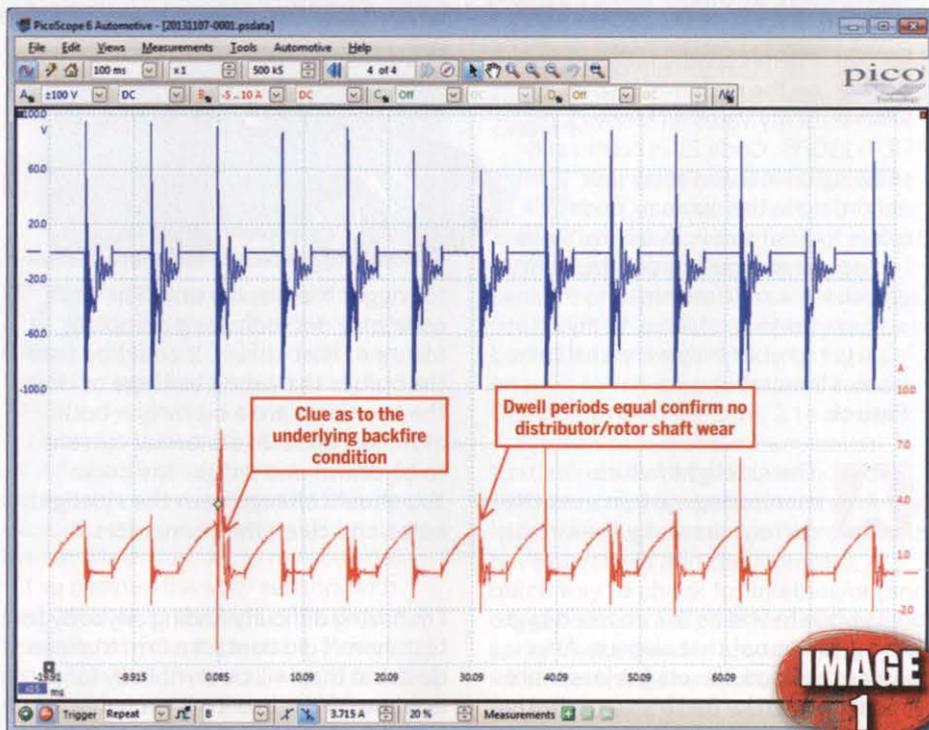
IMAGE 1

Reviewing the ignition captures using the replay feature of PicoScope Automotive software, it was easy to confirm that 'distributor and rotor shaft wear' were NOT at fault, because even though the misfire was clearly evident in our captured trace, the dwell periods remained equal. Often at high rpm, wear in the distributor becomes noticeable due to centrifugal force being applied to the shaft, which, in turn, alters the dwell angle, resulting in a misfire developing (see Image 1).

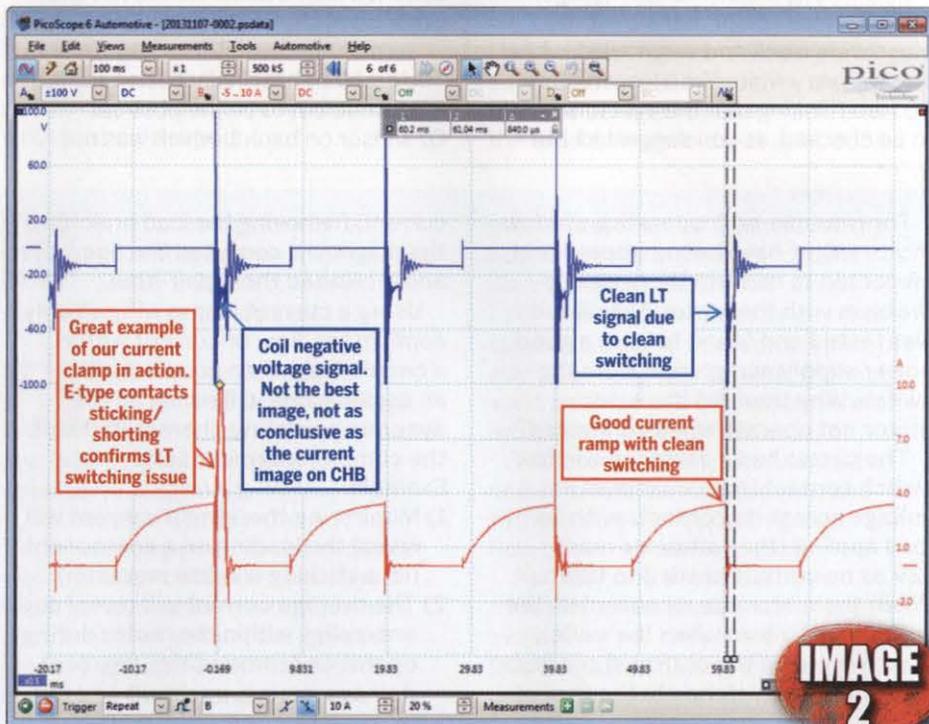
IMAGE 2

Armed with the knowledge that all of the previous checks had thrown up no anomalies and that the dwell angle remained stable, closer inspection of the switching of the primary current revealed excessive, intermittent arcing at the contact breaker points under WOT during the switching stage of 'coil on to coil off'. This, in turn, had an adverse effect on the HT firing voltage and, of course, the HT timing (see Image 2).

The scope trace proved the flow of current after the contact breaker points had opened, confirming the presence of either a short circuit or arcing across the contact points face. Removal of the distributor assembly confirmed the installation of new contact points and a condenser, with no evidence of burning or arcing at the contact breaker point faces. Given these components were new, they could not be relied upon for any relevant witness markings.

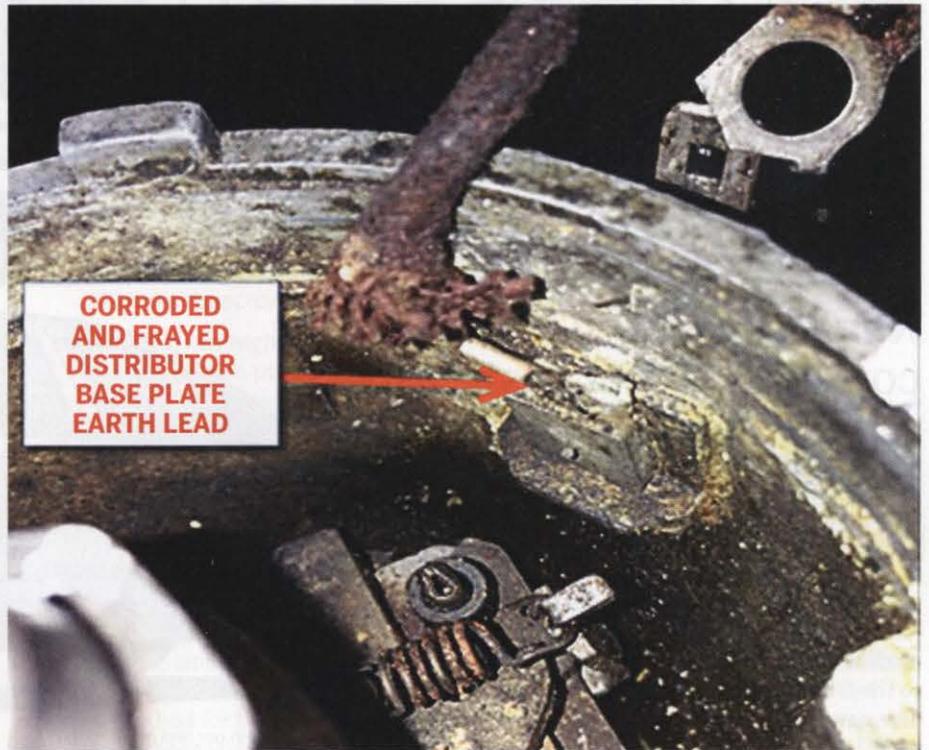
Closer inspection of the distributor base plate revealed there was excessive corrosion between the floating base plate, contact breaker points and base plate earth lead. The contact breaker points ultimately earth the coil primary windings through the distributor base

plate, via a very fine earth lead to the oxidised distributor body and then to earth via the engine block.

The corrosion within this circuit resulted in arcing across the contact breaker points that could not be absorbed by the traditional condenser as the path to earth under WOT increased in resistance with movement of the base plate under centrifugal advance.

After weighing up the pros and cons of simply repairing the earth lead, and given the usage pattern of the vehicle it was recommended we install an electronic ignition kit that removed the earthing issues of the distributor from the equation.
