**Pico Scope Diagnostics by Andy Cape (Cape Auto Diagnostics in Cape Town)**

**DIAGNOSTICS REPORT FOR:**

**MODEL: E46 BMW 318i M43TU**

**COMPLAINTS:**

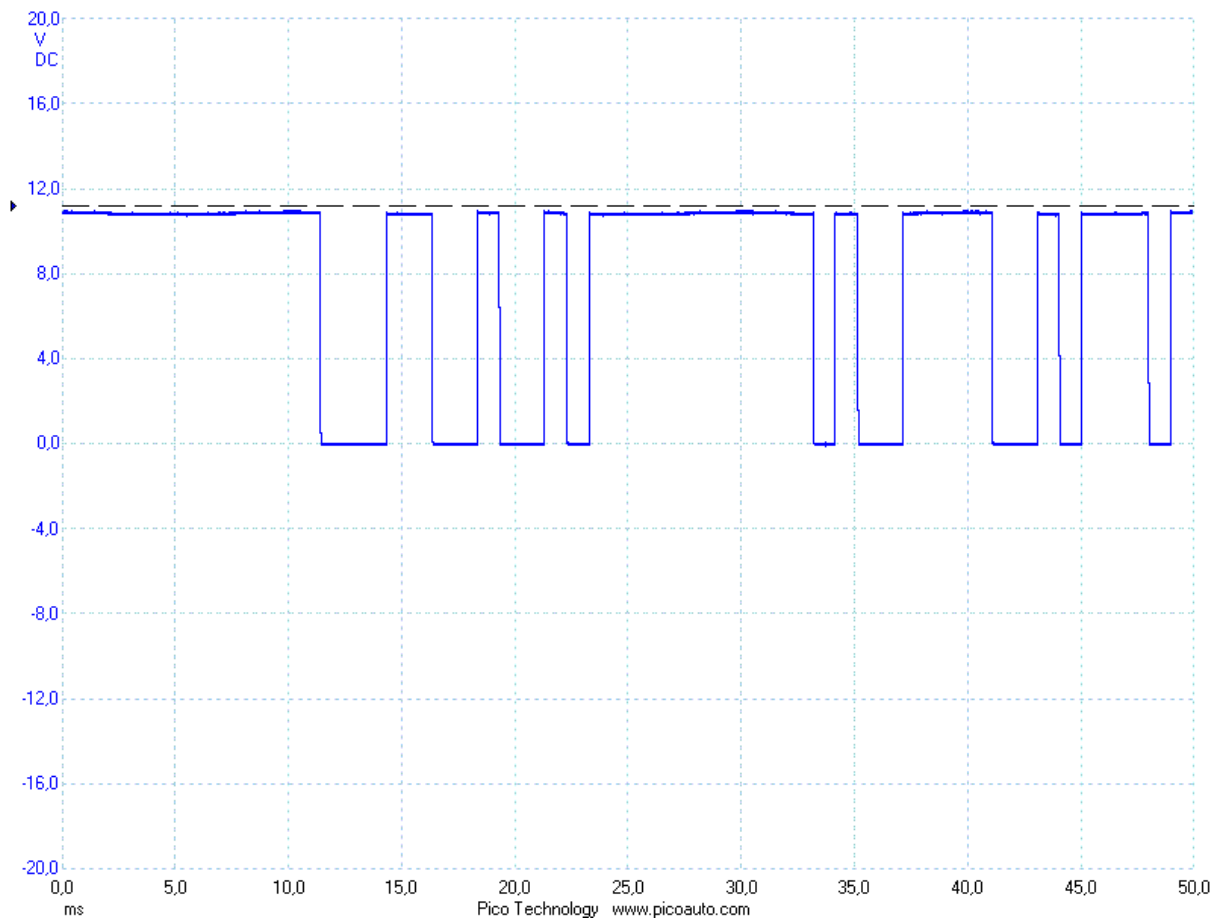
The EWS signal was available as soon the ignition key was turned and therefore it could not to be considered as faulty:

Good EWS signal from immobilizer module to ECU DME input

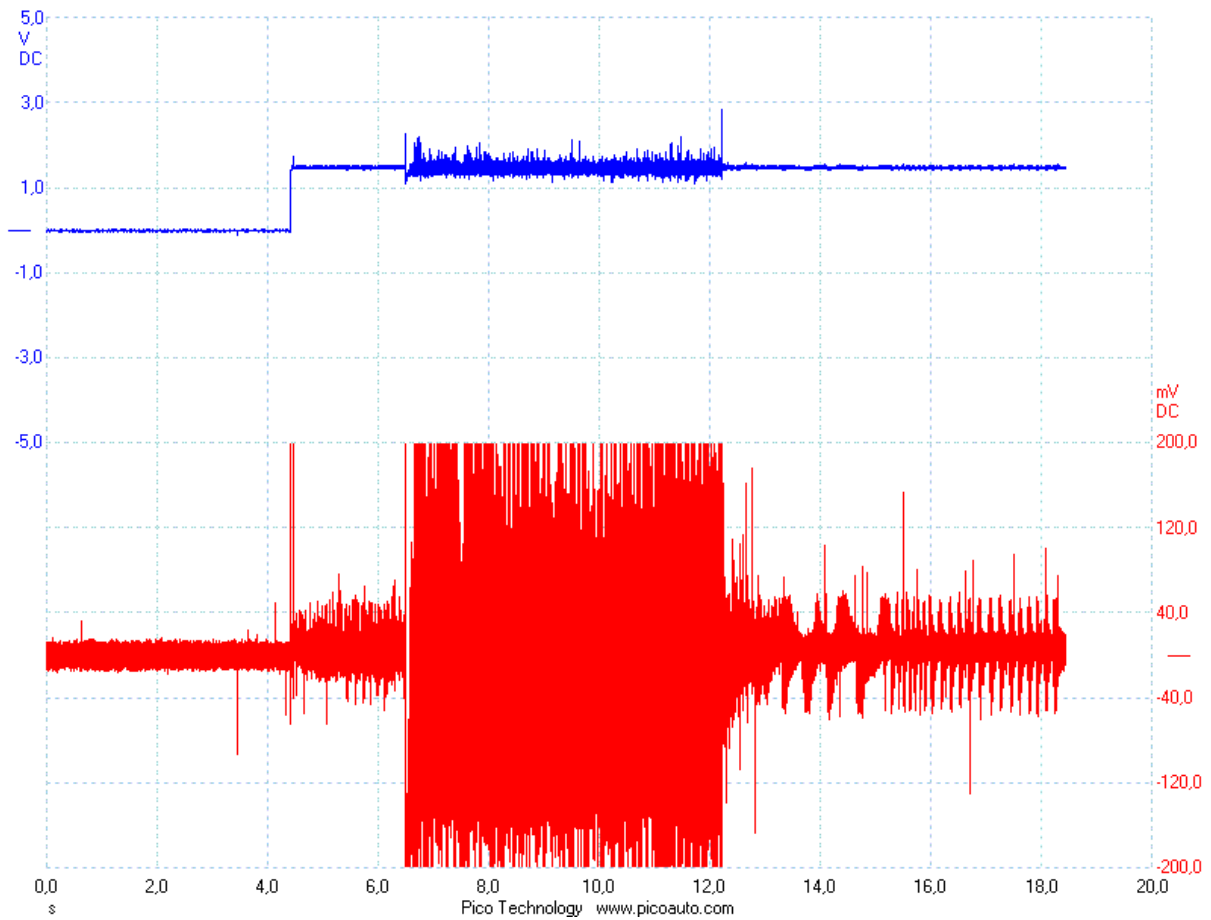
But the Crankshaft Sensor did not deliver a valid signal and also the power supply for the sensor was only 500 mV once the car was started. Blue =Crank shaft sensor, Red = supply of Hall sensor (should be 12V).

We did check the wiring of the Crank shaft sensor and could not find any faults. The sensor itself was replaced by the client already. But also without the sensor connected- there was no sufficient power supply to the sensor from the ECU. Therefore the ECU must be faulty.

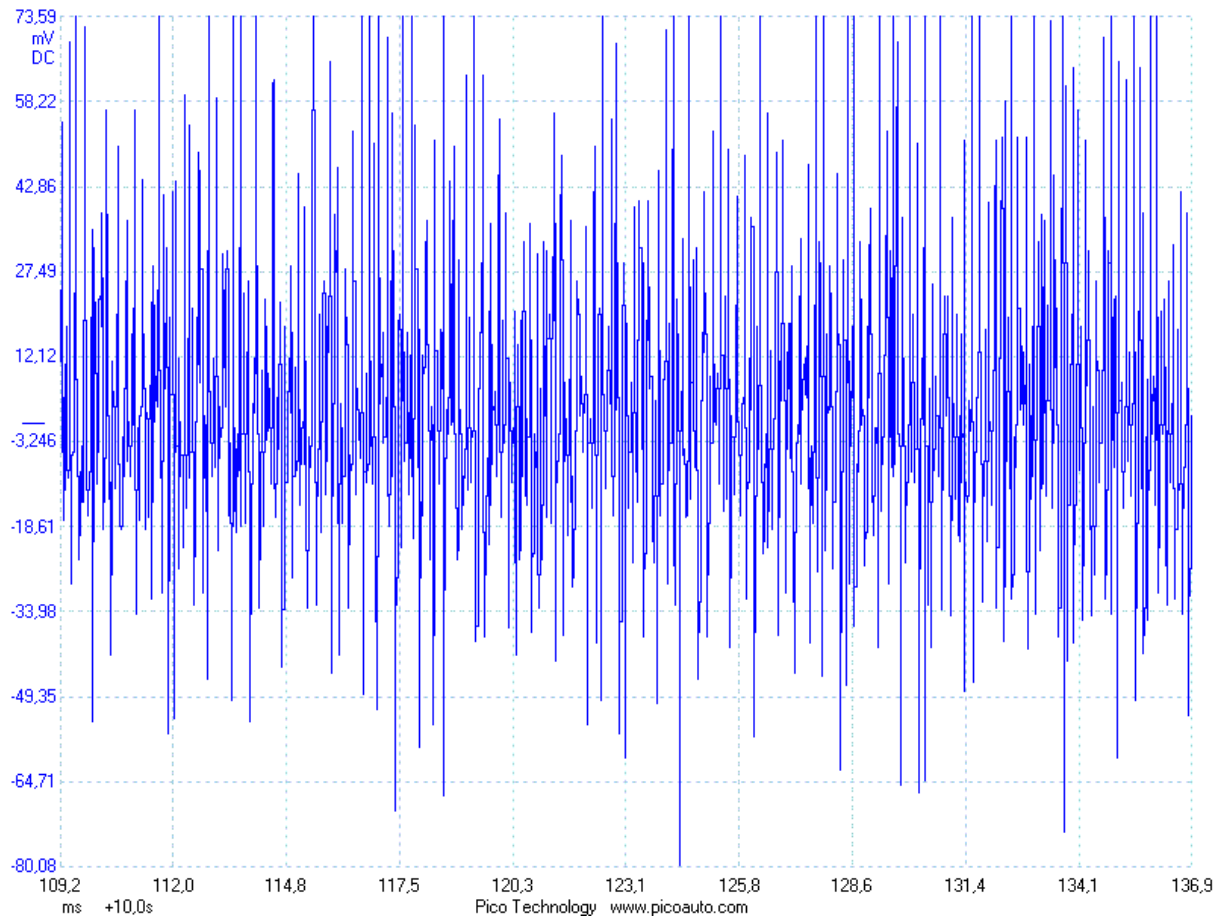
The crank shaft signals zoomed – does not make any sense.

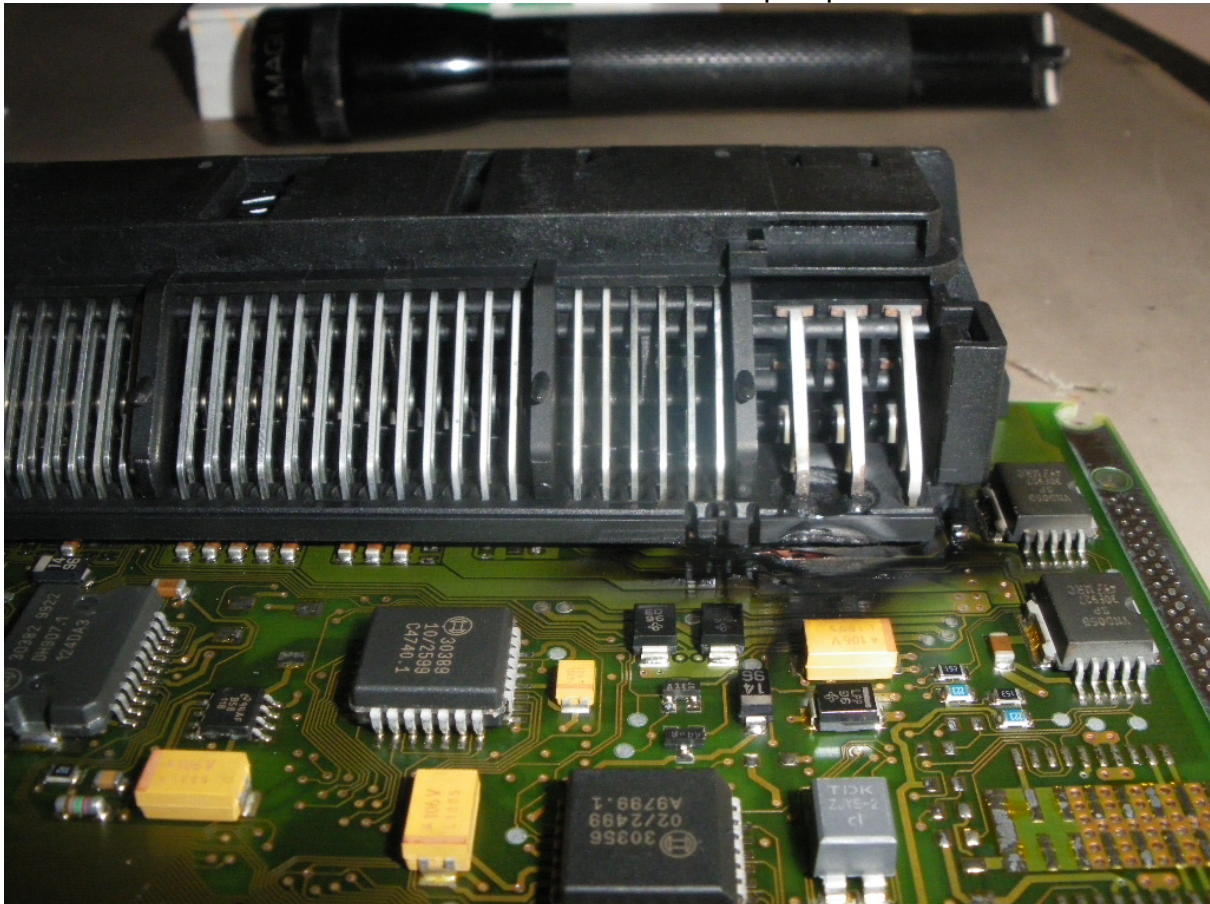
We opened the ECU and found the proof. The Power connector was destroyed by extreme overload. Wonder that all the fuses did not trip to protect the ECU.
