Audi S3 8L Turbo, AMK Engine 2001

03.07.2010

Rough idle / hunting

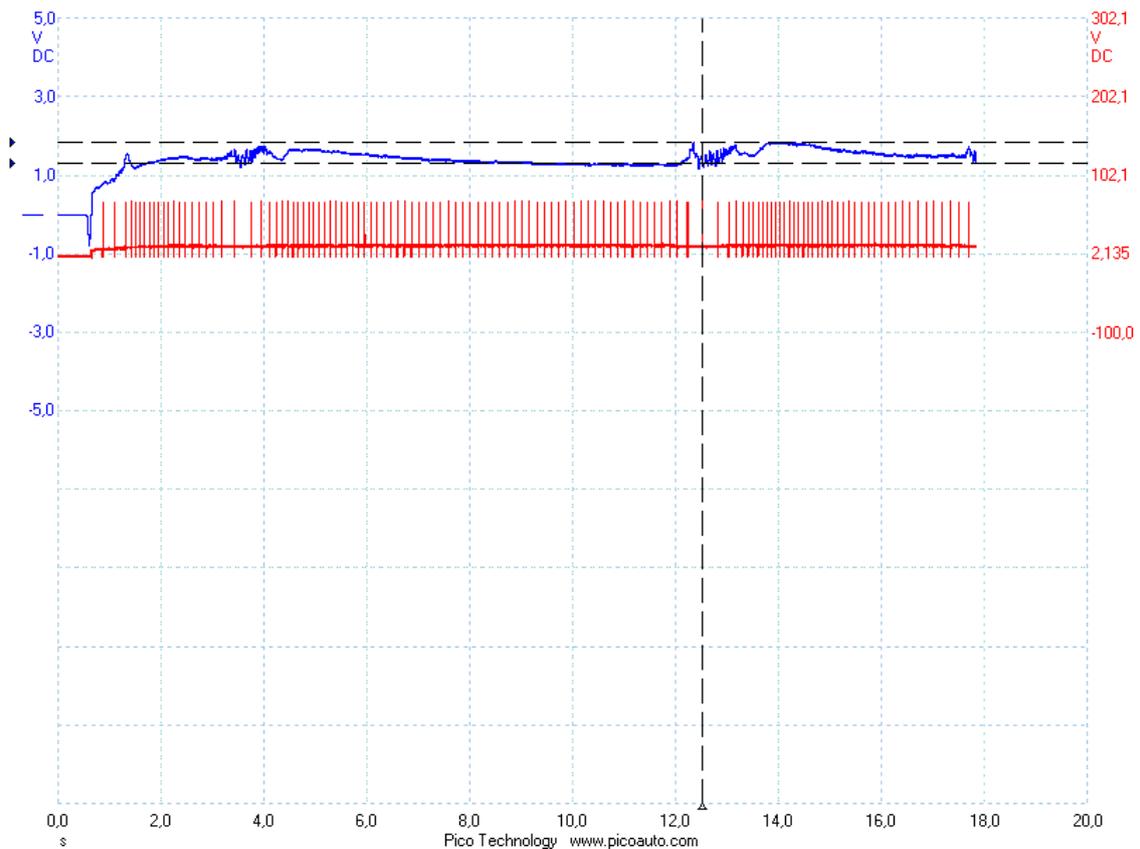
Blue: MAF Red: Injectors #1

The initial test from July 2010 shows a periodically swinging MAF sensor signal from 1.3V (bottom) to 1.8 V (top). The engine idle speed and injector timing is responding to the MAF sensor signal. The engine speed swings from 550 rpm to 1100 rpm and almost cuts out.

A MAF signal of 1.3 V at idle would be normal.

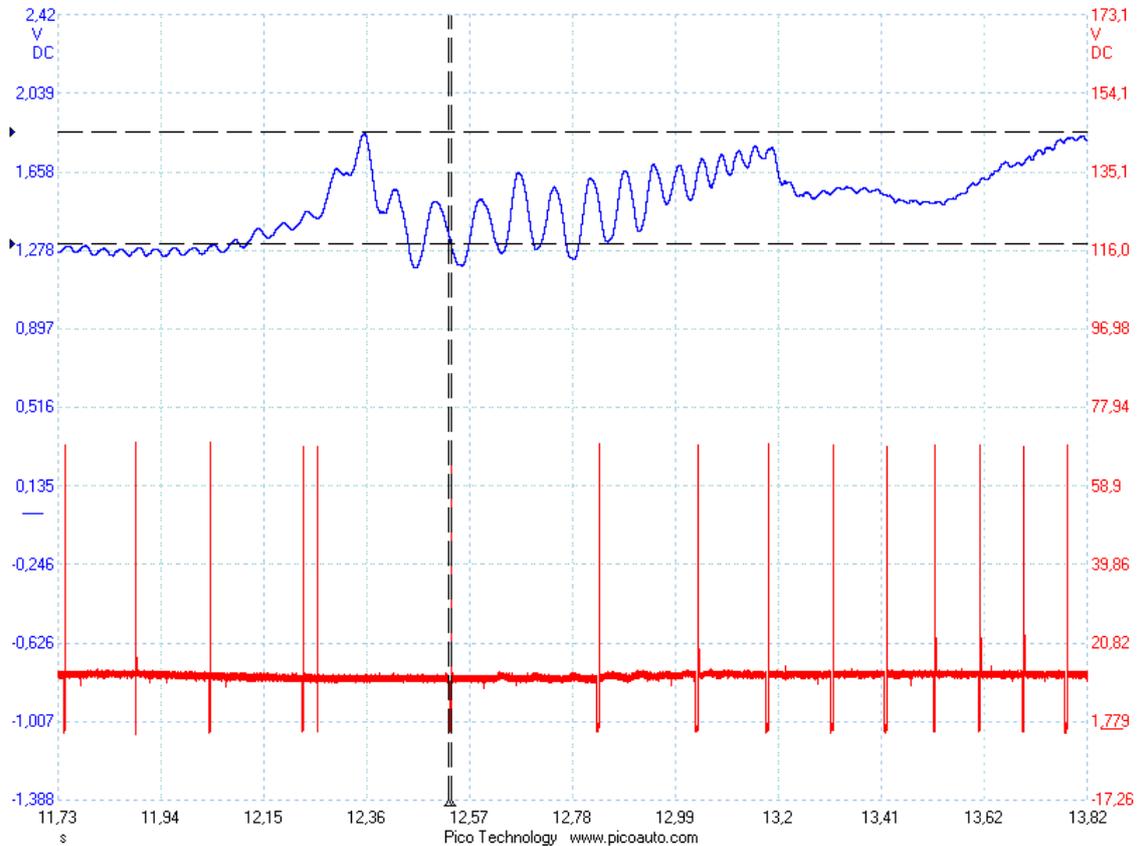
I looked now in detail of the initial scope test from July 2010 to get an idea. It could also be that the engine rpm increased first and than the MAF signal follows with a higher airflow. But from what is the periodically damped swing coming from?

Enlarged: Damped swing over 1 sec. and it is repeated periodically every few seconds

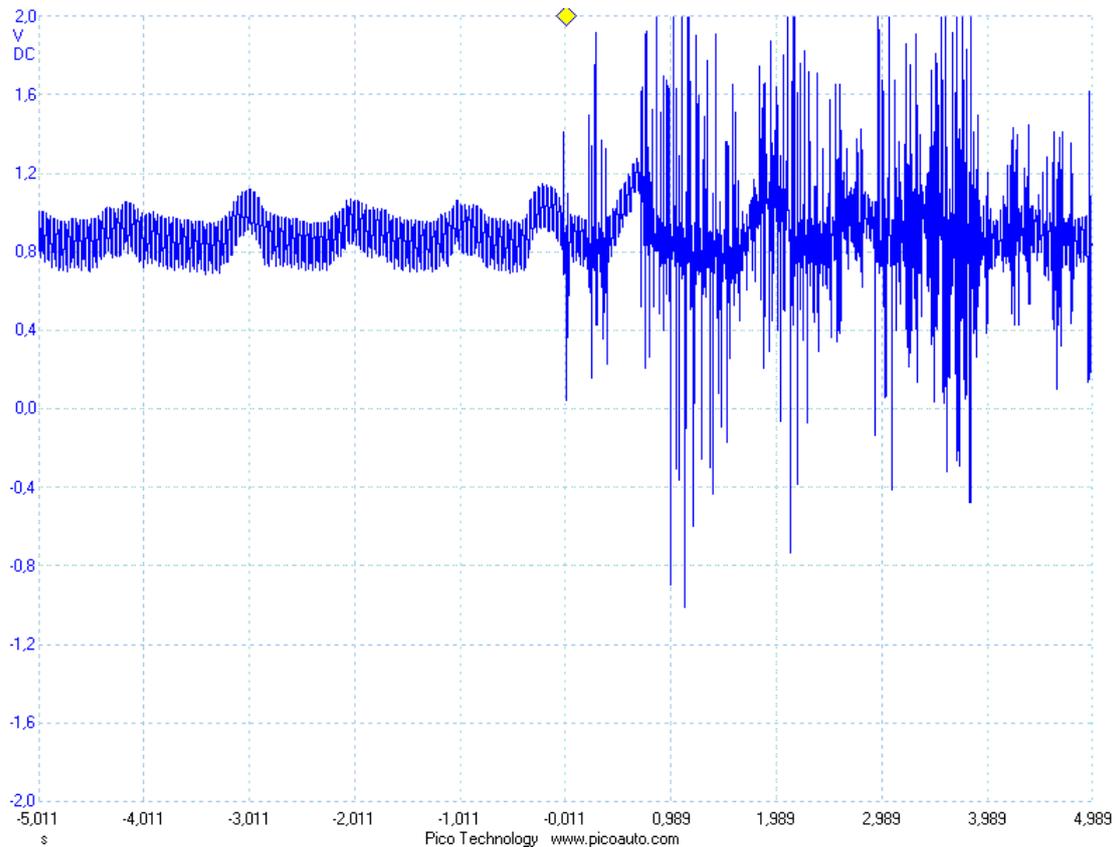
To our amazement – we could not repeat the MAF signal swing any more. It looked sometimes normal 1.3 V over the time – but the engine cut out after a few seconds idling. Sometimes it looked like below: swinging signal and with lot of noise.

As soon we connected the MAF sensor plug – the engine cuts out at idle immediately. We still assumed a vacuum leak but still could not find any.

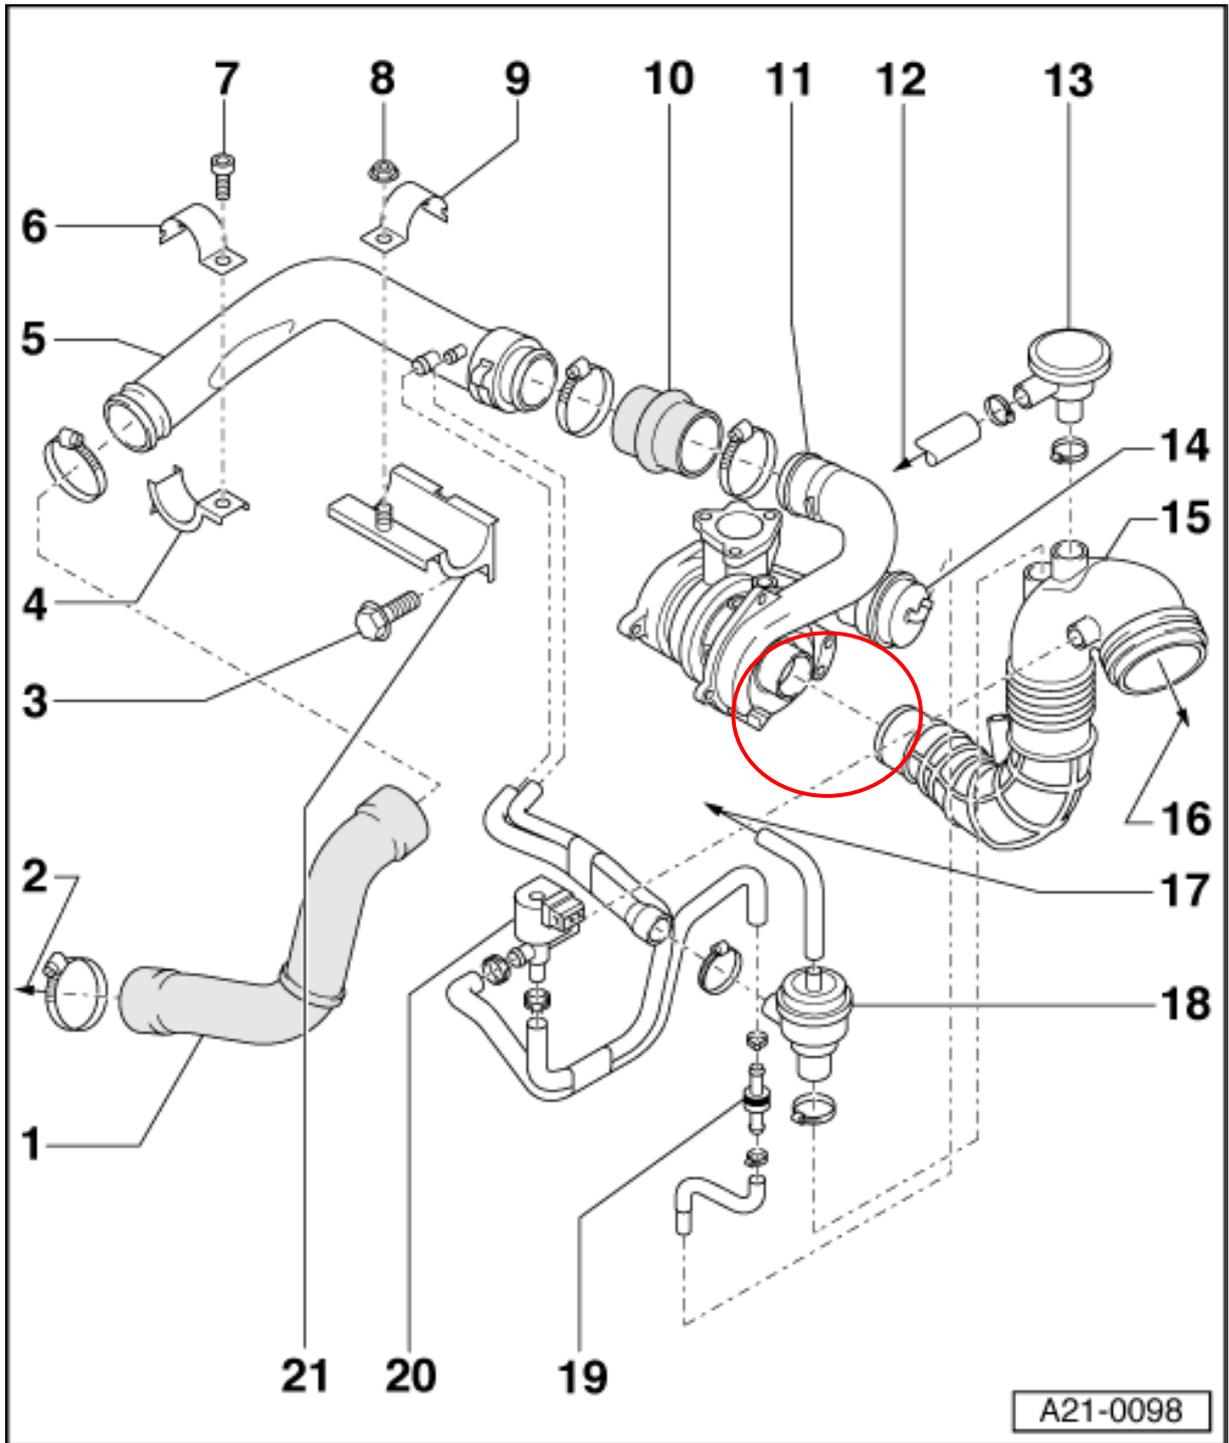
Figure 1: Pos. 16 connected to MAF

The suction duct (rubber elbow) was found completely off from the turbo charger-see red marked position. The connection is buried deep down at the turbo charger and hard to get to.

2nd: To save maintenance on an expensive car is never a good advice. The rubber hose broke because an engine oil leak was not fixed for a long time. (leaking oil from the turbo charger supply).

No wonder that the engine cuts out when the “death” MAF sensor is connected. The broken connection was fixed temporary and the engine idled smooth with connected MAF sensor and did not cut out anymore,
