Polo Classic

Case Study

By: Tamas Krasznai
2013.01.17

Vw Polo Classic 1,6 AKL Engine code

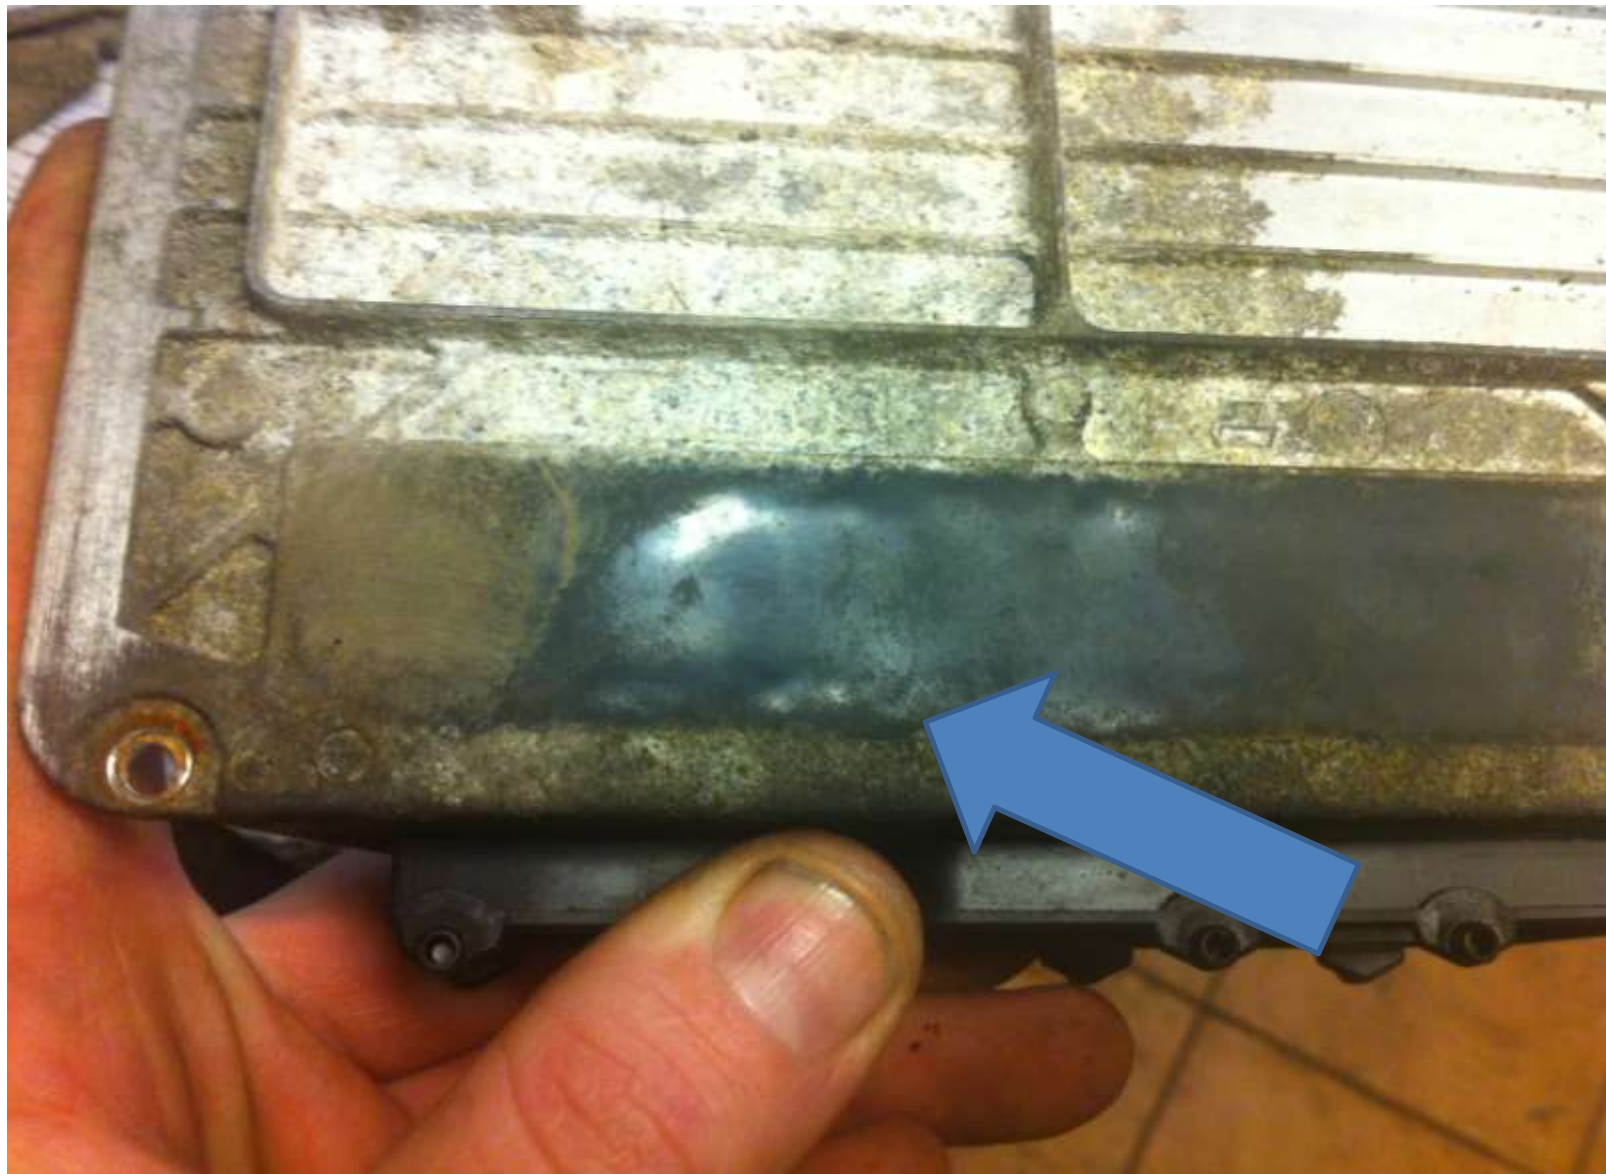
This is where it got wet

The solution: change ECU

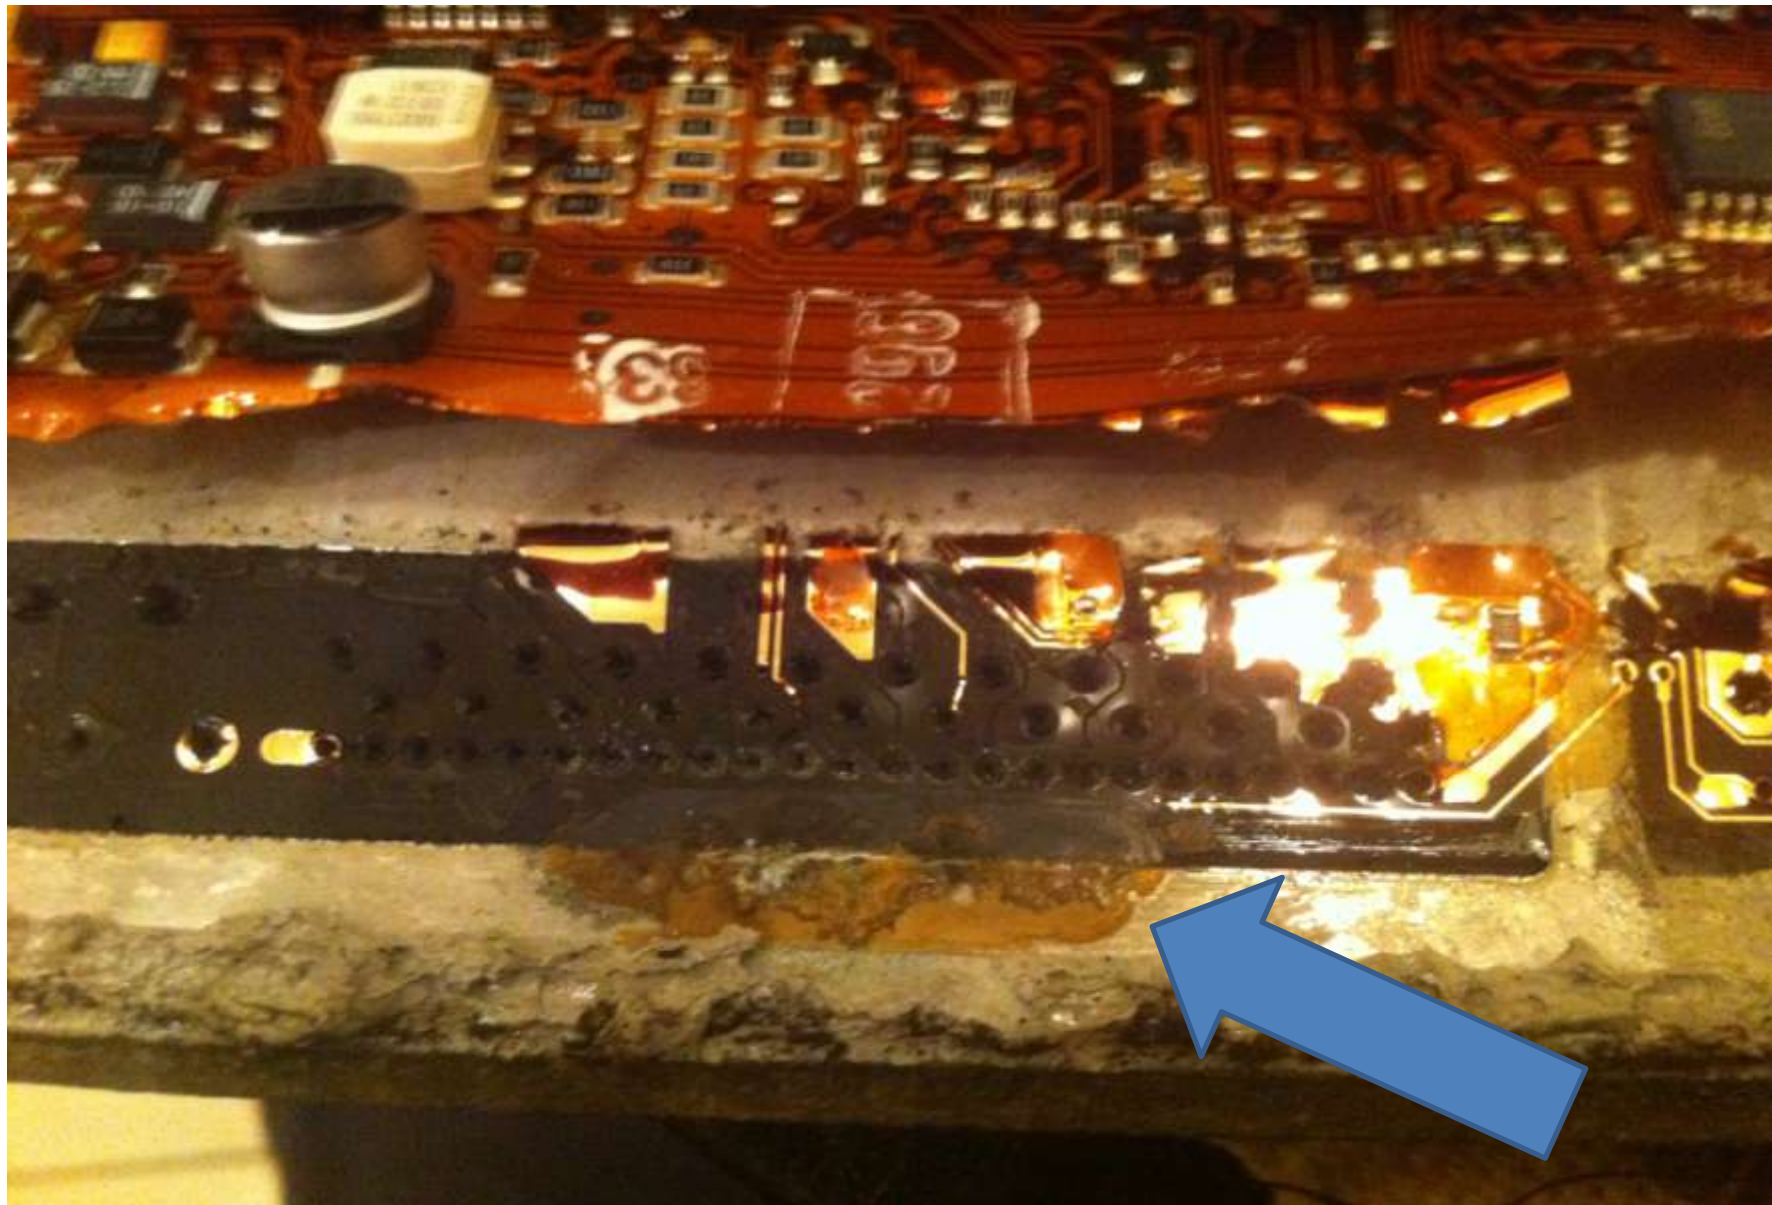
This is where it got wet
