HOW ARE YOU **SCOPING**?

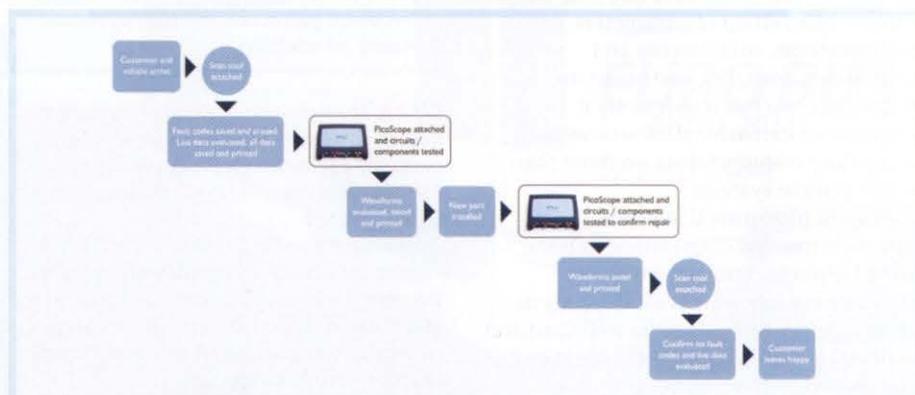
The Pico Journey forms a typical yet simplistic example of how PicoScope sits alongside any scan tool on the road to a successful diagnosis. The flow chart demonstrates how customer expectations can be far exceeded as result of implementing PicoScope during the diagnostic journey, not only ensuring a first time fix, but protecting all parties involved with physical before and after test results. Let's take a look at what is all too often a repeatable scenario when PicoScope is not included in the diagnostic journey.

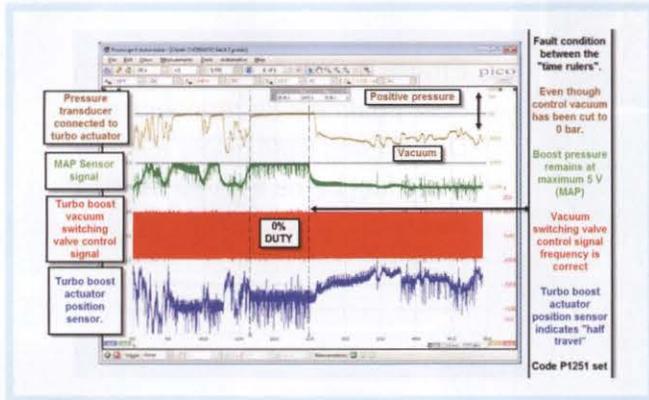
The image above demonstrates how monitoring the input to the boost control VSV and corresponding vacuum in real time via parallel not serial testing (scan tool). We can see live events as they happen and not the ECU's interpretation and presentation of events.

Looking closely at the vacuum control signal supplied to the boost control VSV we can see how the command to reduce boost was sent from the ECU and the correct response was followed by the boost control VSV given the fall in vacuum level to the boost control actuator. However, MAP pressure remained high whilst the boost actuator position sensor indicating only half travel.

From the above captured data we can conclude the ECU to be functioning correctly as the command signal to reduce boost was sent. We can confirm the wiring to the boost control VSV and the valve/hose network to be functioning correctly as reported by the pressure transducer, leaving only one possible explanation for the failure in the reduction of manifold pressure... Turbo charger variable vanes sticking.

The turbo charger is replaced with confidence resulting in minimal impact on workshop loading. The vehicle is then returned to service in a timely fashion leaving a lasting positive impression upon the customer.
