Polo Classic

Case Study

By: Tamas Krasznai
2013.01.17

Vw Polo Classic 1,6 AKL Engine code

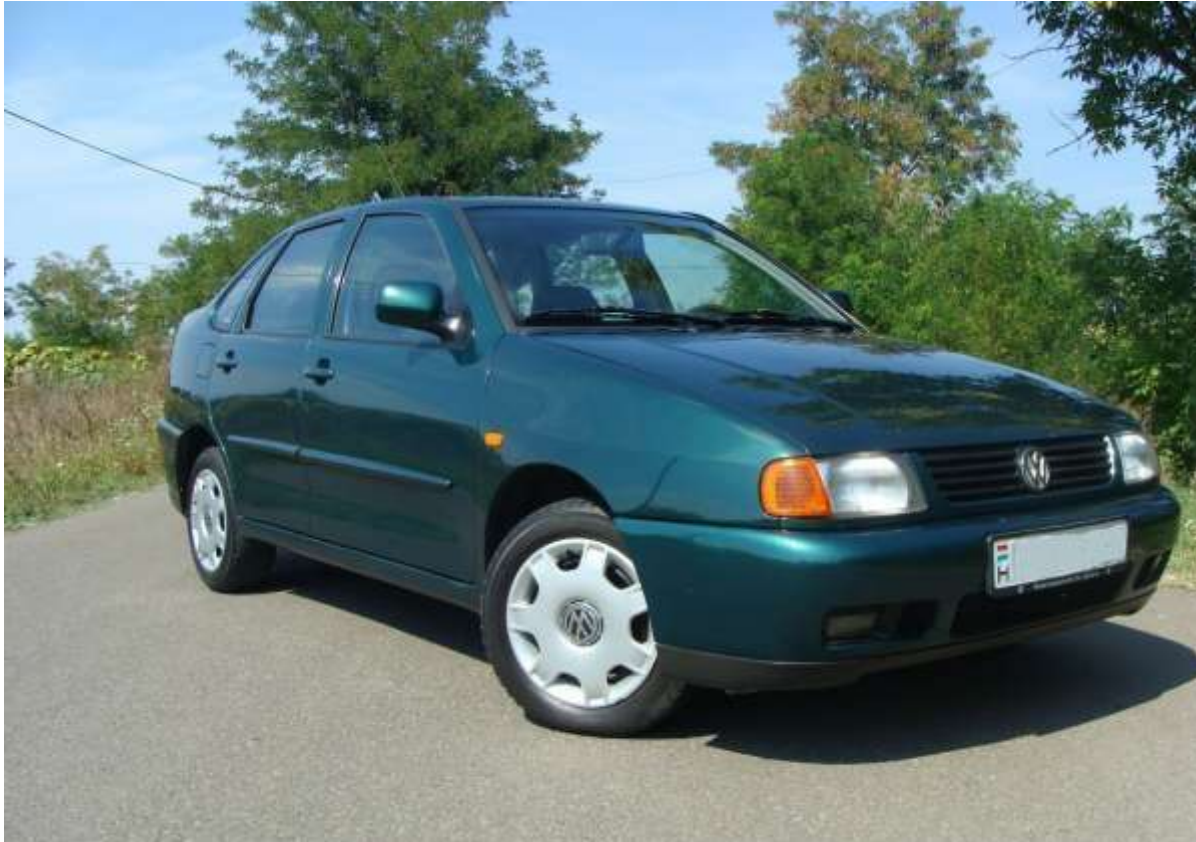
- The engine will not start
- If it starts it goes well for a while then stops
- DTC: camshaft position sensor
crankshaft position sensor
engine coolant temperature sensor
throttle position sensor
short circuit to positive

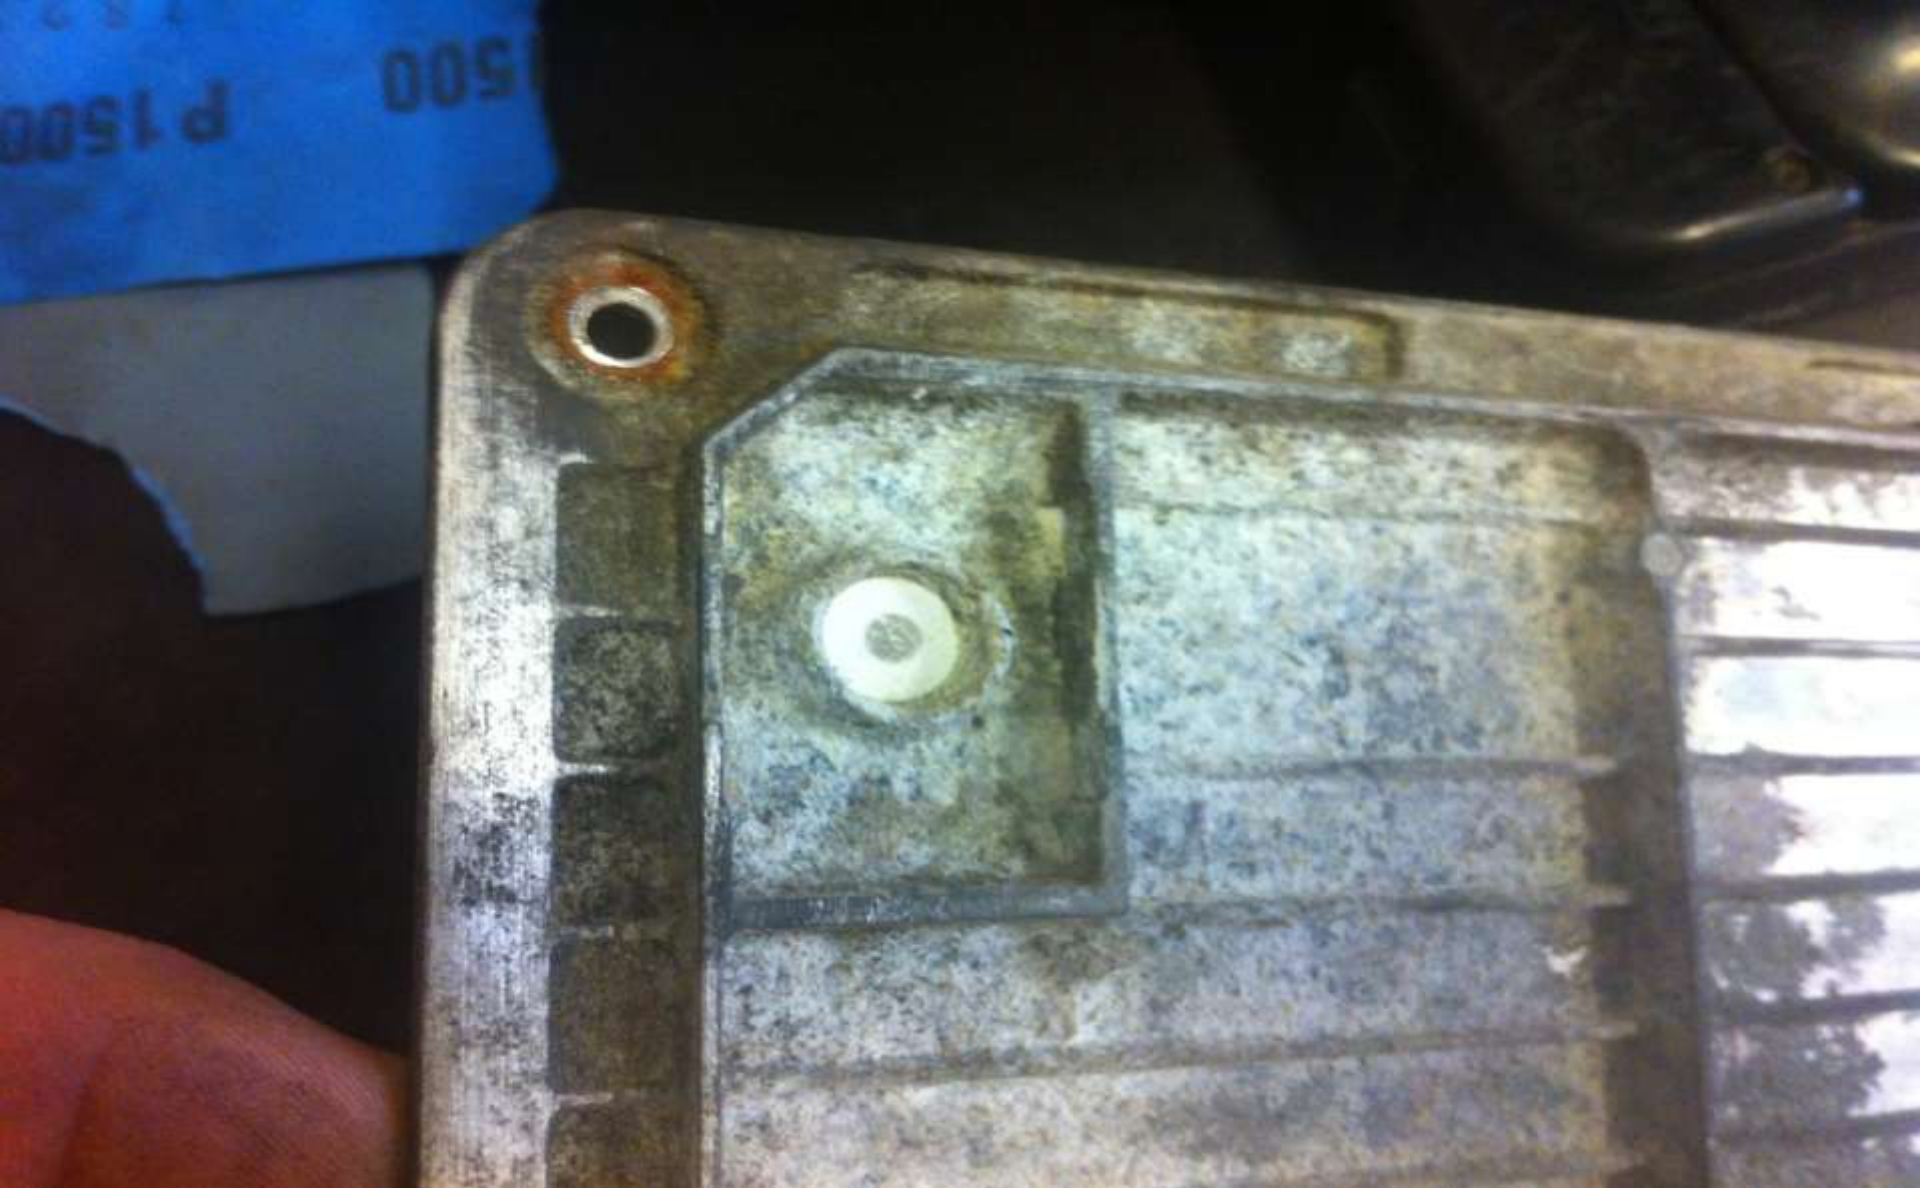
This is where it got wet
